**STEVENS POND OUTLET DAM**

**MA 00232**

**PHASE I INSPECTION REPORT  
NATIONAL DAM INSPECTION PROGRAM**

**AUGUST 1978**

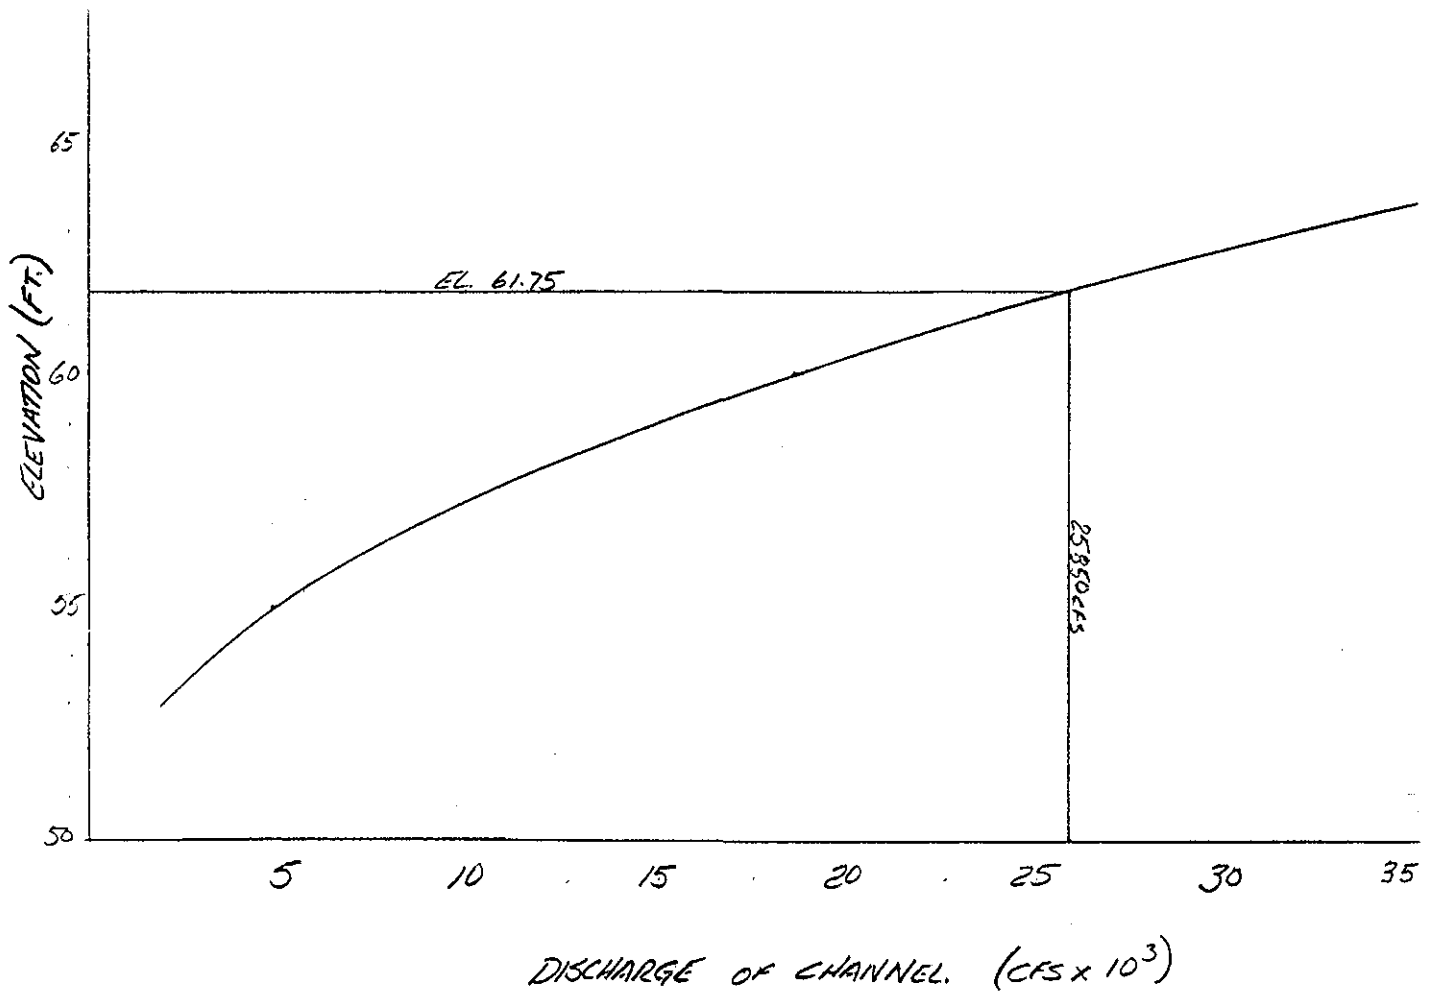
REACH I  $Q = 25850$  CFS. EL. 61.75

RESULTS IN FIRST REACH DISASTROUS - EXTREME FLOODING  
THROUGH FACTORY AREA - OVER BROADWAY INTO RESIDENTIAL  
AREA. LARGE HAZARD TO LIFE
